# A Clean Up The Lake Report

## Results of the 2024 Donner Lake Deep Dive Cleanup – Town Of Truckee, CA

June 30, 2025

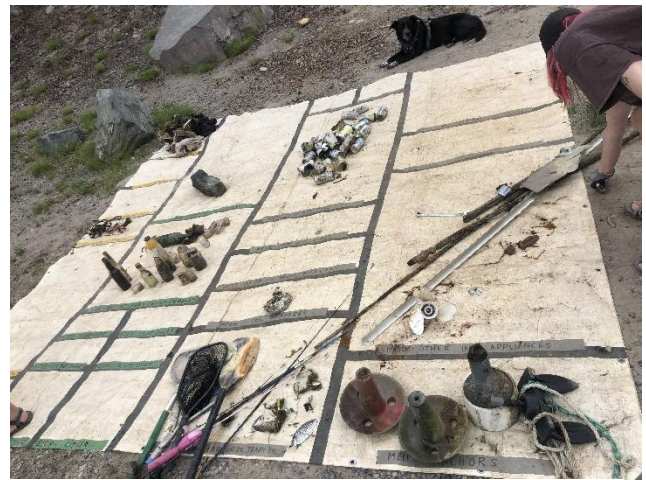
**Figure 4:** Lakebed litter retrieved from dive site and sorted onto tarps using litter categorization methods.

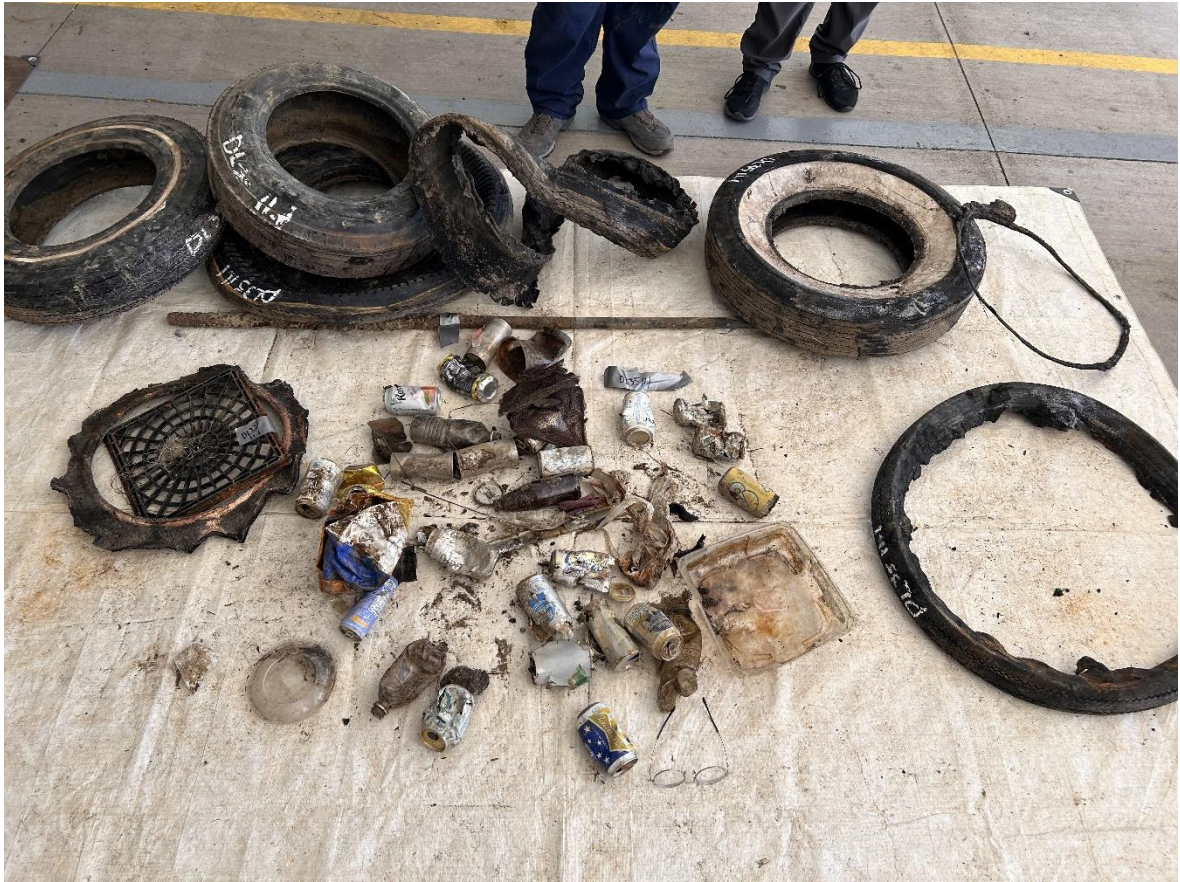
Dive 11.1.LM24 yielded the highest amount of litter removed by weight, with a total of 284 pounds (*Figure 18*). However, it accounted for only 5% of the total number of litter items removed by count. Notably, divers recovered 14 tires during this dive, which alone made up 44% of the total weight collected at this location. This illustrates that when divers encounter large, heavy debris, they may remove fewer individual items, yet still remove a significant amount of litter from the underwater environment. It also demonstrates the importance of considering both item count and weight when assessing cleanup effectiveness.

**Figure 18:** Lakebed litter retrieved from dive site 11.1.DL24.

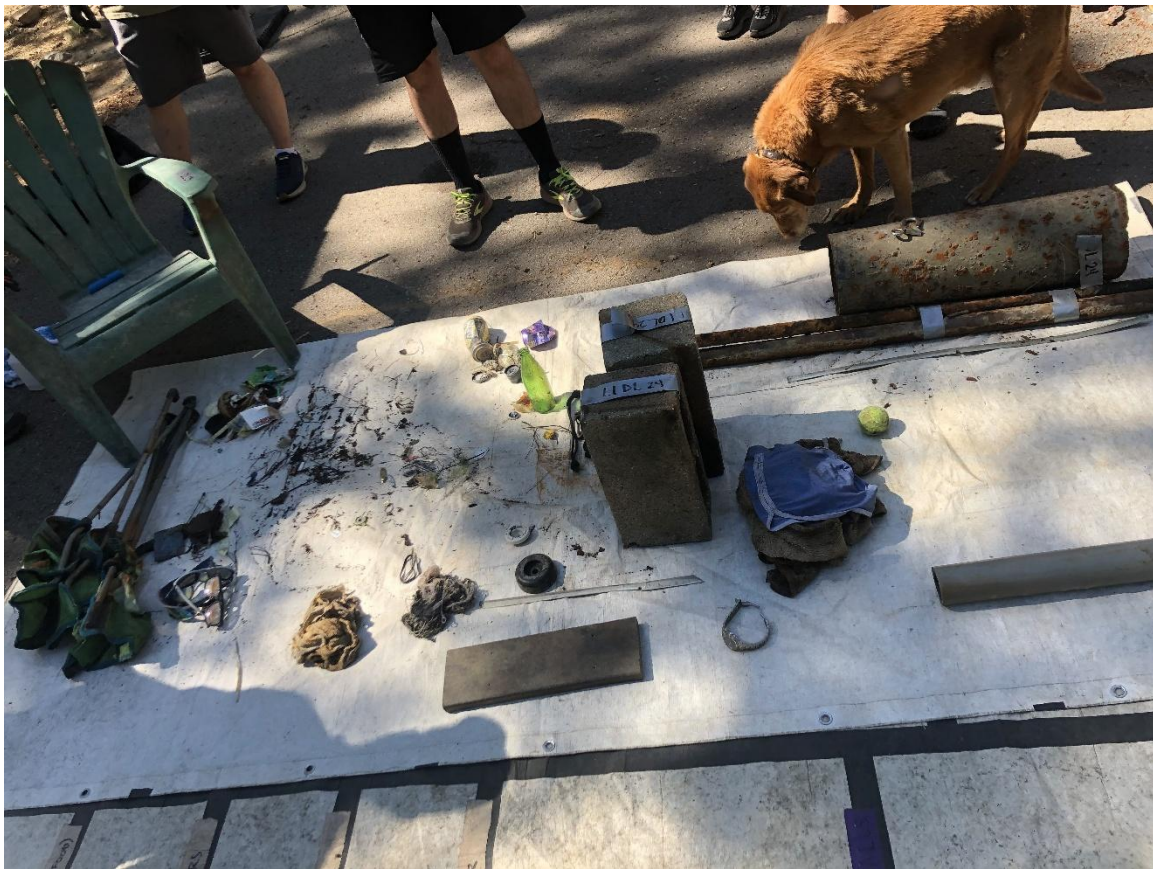
The dive with the highest number of items removed was dive 1.1.DL24 with a total of 135 pieces (*Figure 19*). It also accounted for 10% of the overall litter removed by both weight and count. While plastics made up the highest proportion of items collected during this dive by count (44%), they only contributed 9% of the total weight, indicating the presence of small lightweight plastic litter. In contrast, metal and glass & ceramic debris, though smaller in number (29% and 6% of total items, respectively), accounted for a combined 85% of the total litter weight removed during this dive. The image below shows the successful removal of a beach chair, several concrete block, and a variety of metal items including piping and rebar.

**Figure 19:** Lakebed litter retrieved from dive site 1.1.DL24.

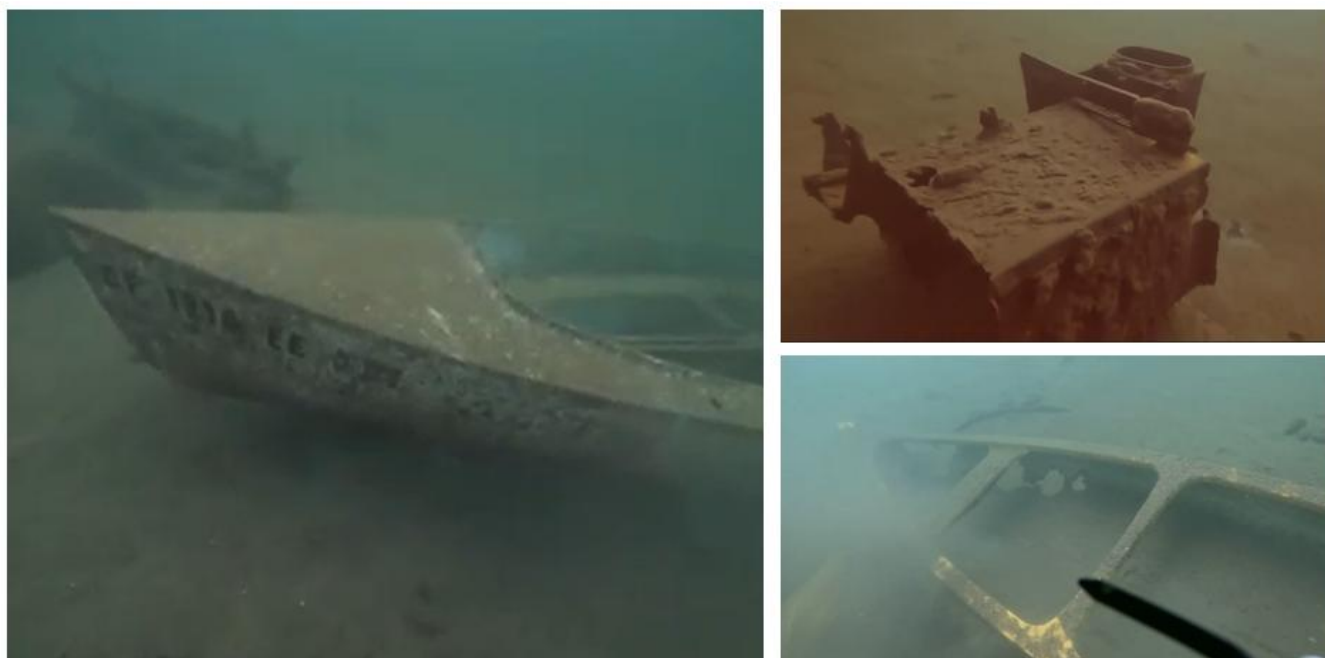
| Date | Dive | Depth (ft) | Description |
|---|---|---|---|
| 12/6/2024 | 8.1.DL24 | 45 | Oven ( <i>Figure 20</i> ) |
| 1/21/2025 | 11.1.DL24 | 45 | Boat, possibly a smaller race sailing dingy ( <i>Figure 20</i> ) |
| 5/14/2025 | 12.1.DL24 | NA | Canoe off public dock #27. ( <i>Figure 20</i> ) |

**Figure 20:** Notable heavy lift items documented but not removed during the 2024 Deep Dive Cleanup. Left: Boat observed during dive 11.1.DL24. Upper right: Oven identified during dive 8.1.DL24. Lower right: Canoe located off public pier #27.

This data provides a critical foundation for prioritizing future litter retrieval projects, particularly in areas where clusters of heavy debris, abandoned mooring structures, and other difficult-to-remove items exist. These findings highlight the need for collaboration with professional dive crews and surface support with heavy lift capabilities to ensure the safe removal of larger underwater objects. Our work in Donner Lake from 2020 to today presents a compelling case for organizing a dedicated Donner Lake Heavy Lift Cleanup. This project could focus on targeted removal of these heavy lift items utilizing lift bags, boats, and additional diver support to extract large-scale pollutants.
